TECHNICAL REPORT

**A20 LONDON ROAD BETWEEN M26 AND M20 OFF SLIP
(EASTBOUND), WROTHAM, KENT**

ROAD SAFETY ISSUES

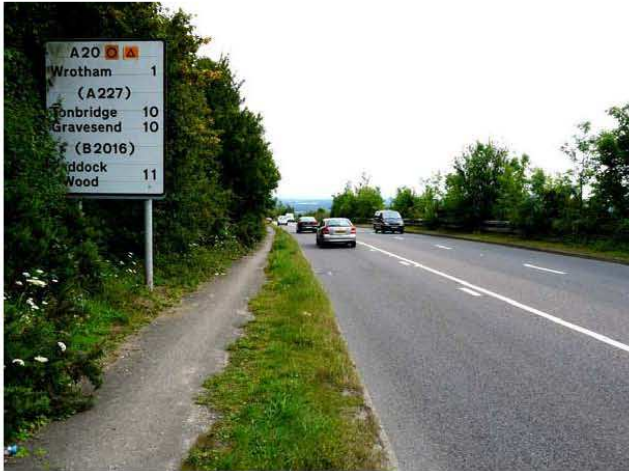
Photo I

- 2.6 The road layout is similar between the junctions of the A20 with A227 Gravesend Road in the east and the M20 off slip and Old Coach Road in the west. The statutory speed limit here is also 60mph and the length of this section is approximately 1.4km long. Refer to photo I, III and V in Appendix.

Top of Wrotham Hill.
Speed Limit : 60mph on steep gradient.
Central lane hatched allowing overtaking where conditions allow.

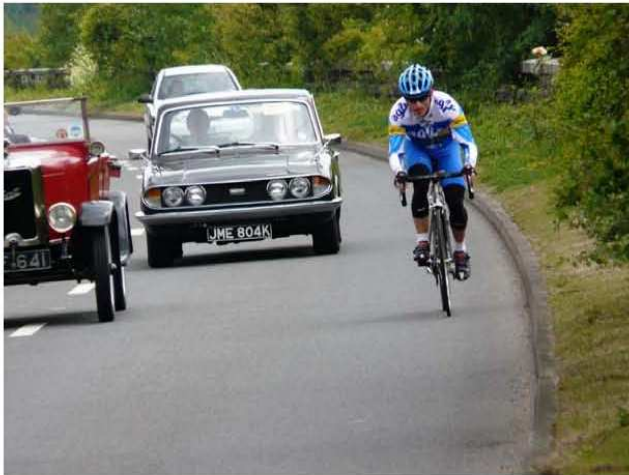
Photo II

- 2.8 The route is very popular for cyclists as the route provides a particularly attractive challenge for cycle clubs who often use the route for informal cycle trials and in preparation for organised events elsewhere. Refer to photo II in Appendix.

Top of Wrotham Hill.
Speed Limit : 60mph on steep gradient.
Central lane hatched allowing overtaking where conditions allow.

Cyclist approaching the top of Wrotham Hill. It is a good illustration of the effect on traffic flows.

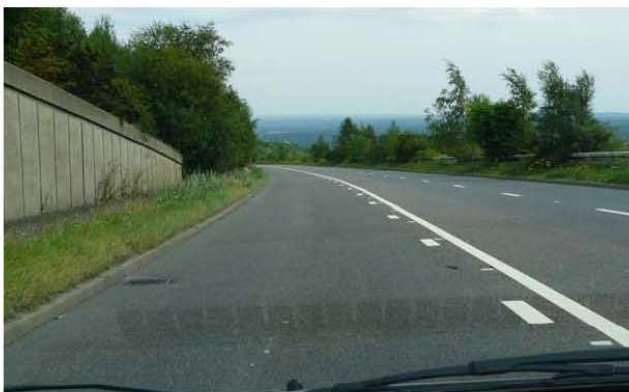
Photo III

Centre of Wrotham Hill.
Speed Limit : 60mph on steep gradient.
Central lane hatched allowing overtaking where conditions allow.

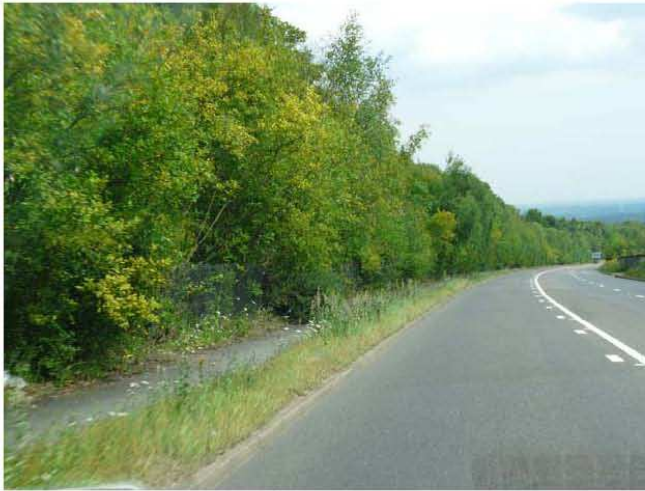
Photo IV

**Centre of Wrotham Hill
Speed Limit : 60mph on steep
gradient.
Central lane hatched allowing
overtaking where conditions
allow.**

**Note the vegetation is
obstructing the pathway.
Cyclists have been observed
attempting to use this safer
alternative but the vegetation
prevents this at several
positions.**

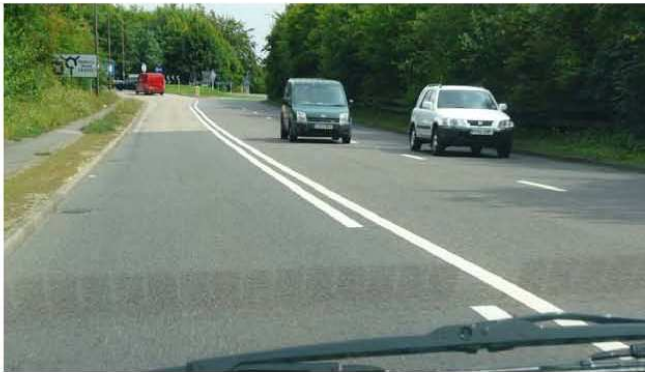
Photo V

**Bottom of Wrotham Hill.
Speed Limit : 60mph on steep
gradient.
Central lane solid approaching
Gravesend Road roundabout.**

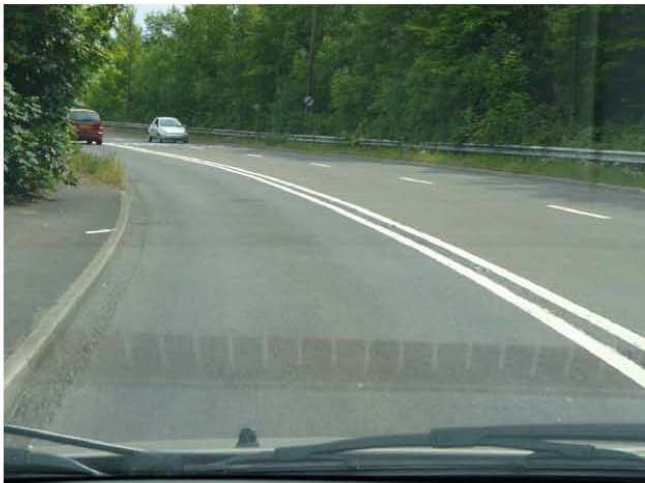
Photo VI

- 2.5 Sections close to the roundabouts at either end are marked with double white lines prohibiting overtaking, refer to photo VI in Appendix, but between these sections the dividing road markings take the form of a solid white line on the 2 lane side and a dashed line on the single lane side allowing overtaking where conditions allow. The statutory speed limit is 60mph and the length of this section is approximately 600m long.

**Past Gravesend Road
roundabout.
Speed Limit : 60mph on steep
incline.
Central lane solid close to
roundabout only.**

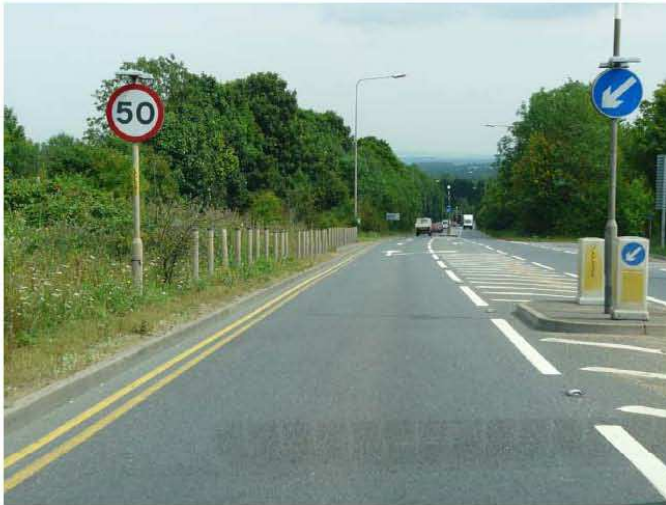
Photo VII

Past Whitehill roundabout
Speed Limit : reduces to
50mph as gradient reduces.

Single carriageway with
central hatching forming ghost
island right turning facilities at
numerous locations.

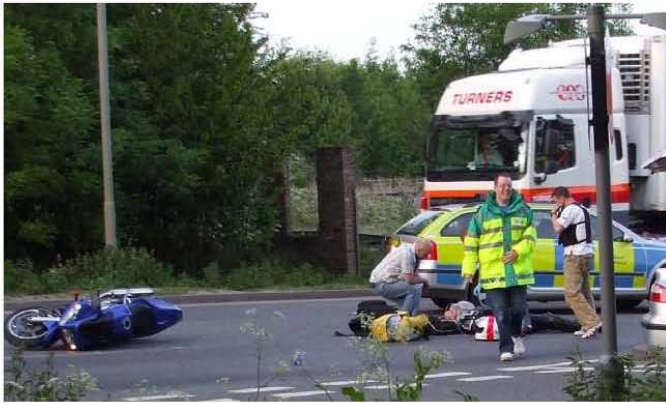
Photo VIII

London Road, outside of the
Marley depot.
Speed Limit : 50mph on
moderate gradient.
Accident involving
motorcyclist in 2008.
