Kent Pedestrian Guard Railing Assessment

Tonbridge – Consultation Report

November 2010

Project Number B1555300

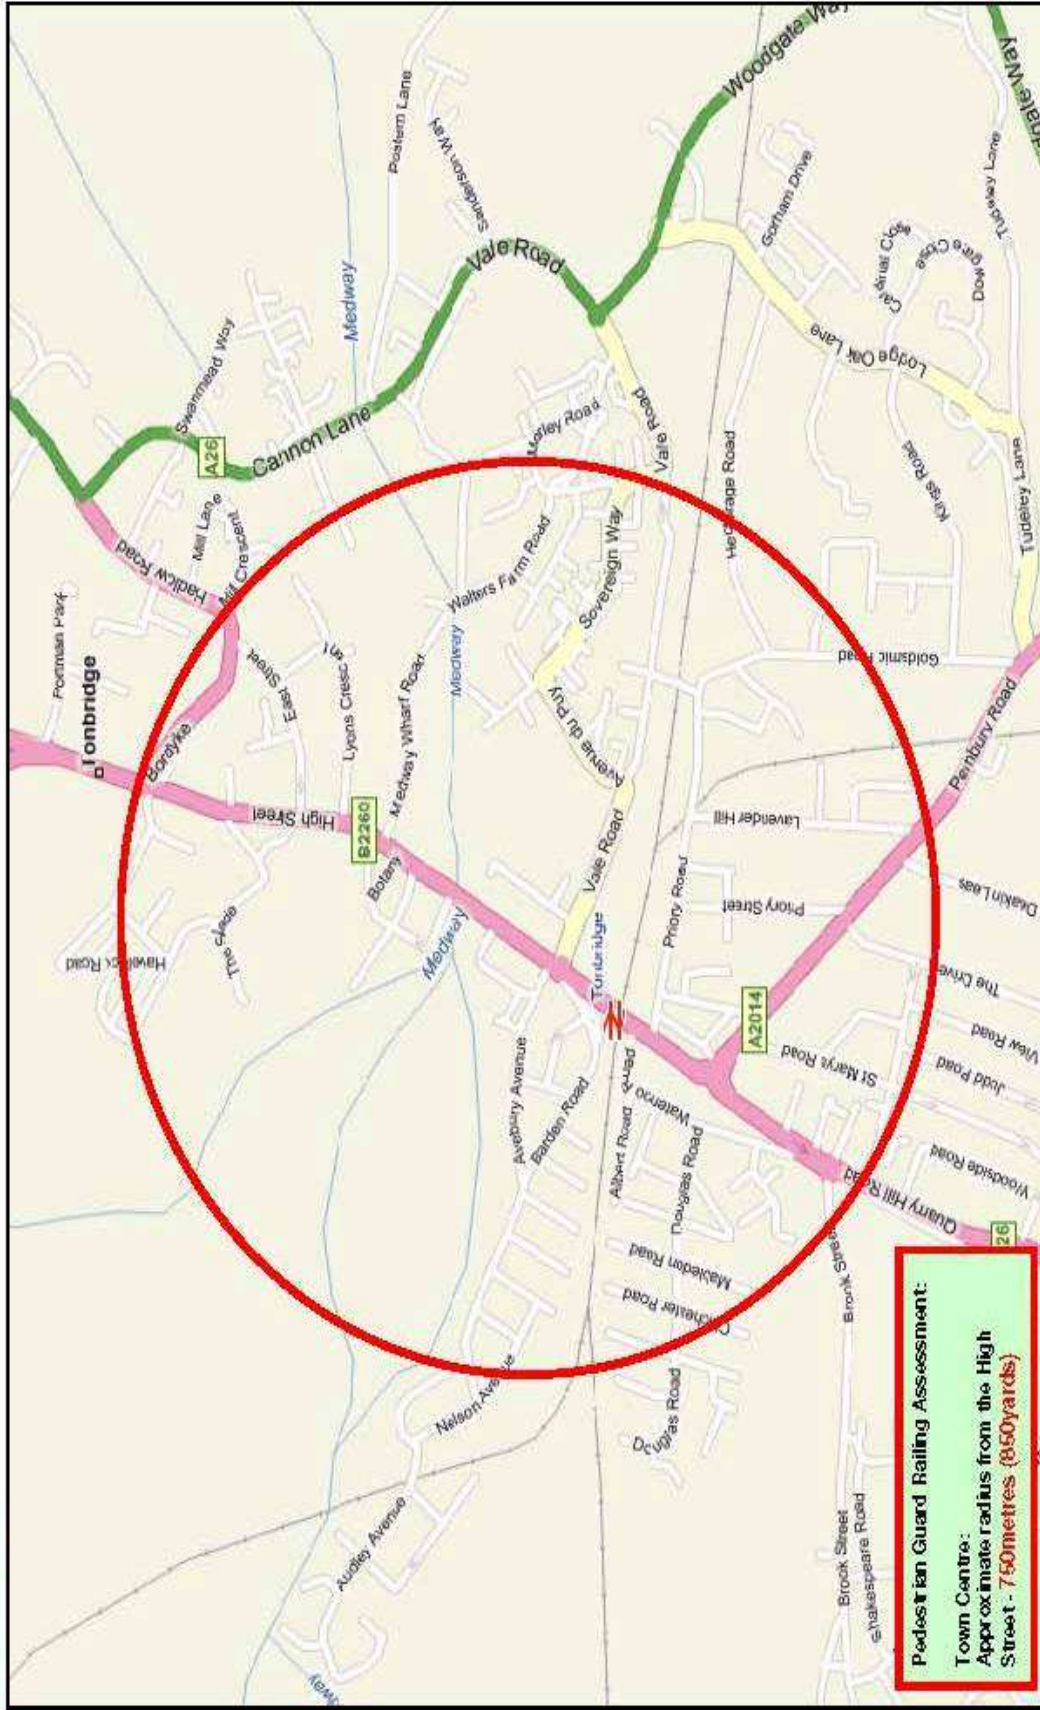
The assessments were conducted within an approximate 750metre (820yard) radius (1 mile diameter) of the High Street to incorporate the main pedestrian thoroughfares in the town centre (see figure 1). Following a request from T & D the assessment was extended to cover the pedestrian guard railing at a site in Hildenborough also.
