## **Kent Pedestrian Guard Railing Assessment**

### **Tonbridge – Consultation Report**

November 2010

Project Number B1555300

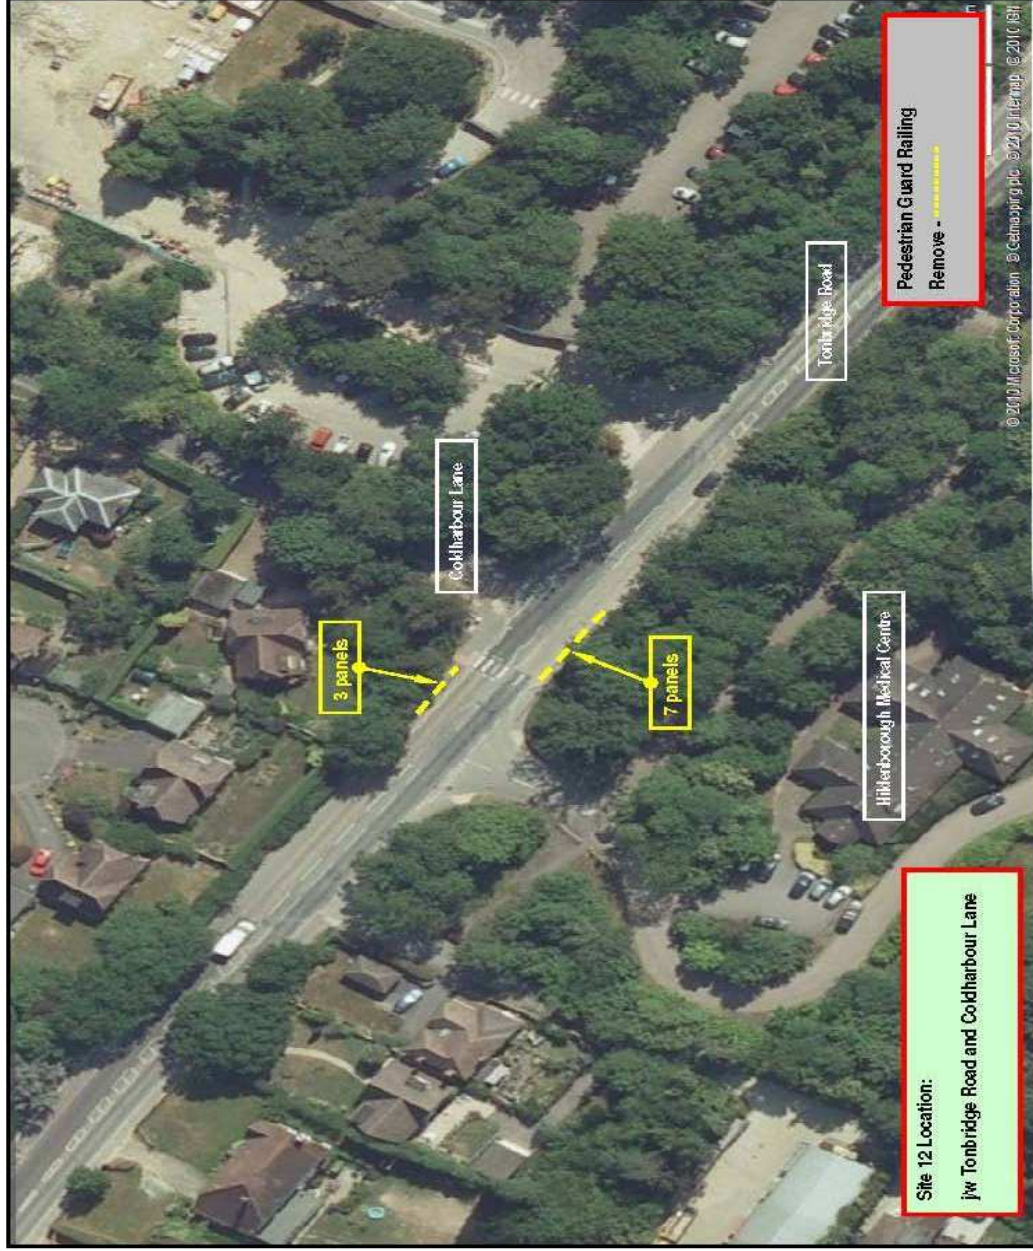
Site 12 Location:  
J/w Tonbridge Road and Coldharbour Lane

The pedestrian guard railing is located outside Hildenborough Medical Centre. The southern footway width is restricted by a hedge and the guard railing, rendering the footway only 1.90metres wide.

The pedestrian guard railing offers little benefit as a guide or protective device.

Pedestrian Guard Railing  
Remove

3 panels

7 panels

- **It is recommended to remove the pedestrian guard railings at site 12.**
