Technical Note

165 Watringbury Road

19-039-001 Rev A

Proposed Access & Visibility Splays

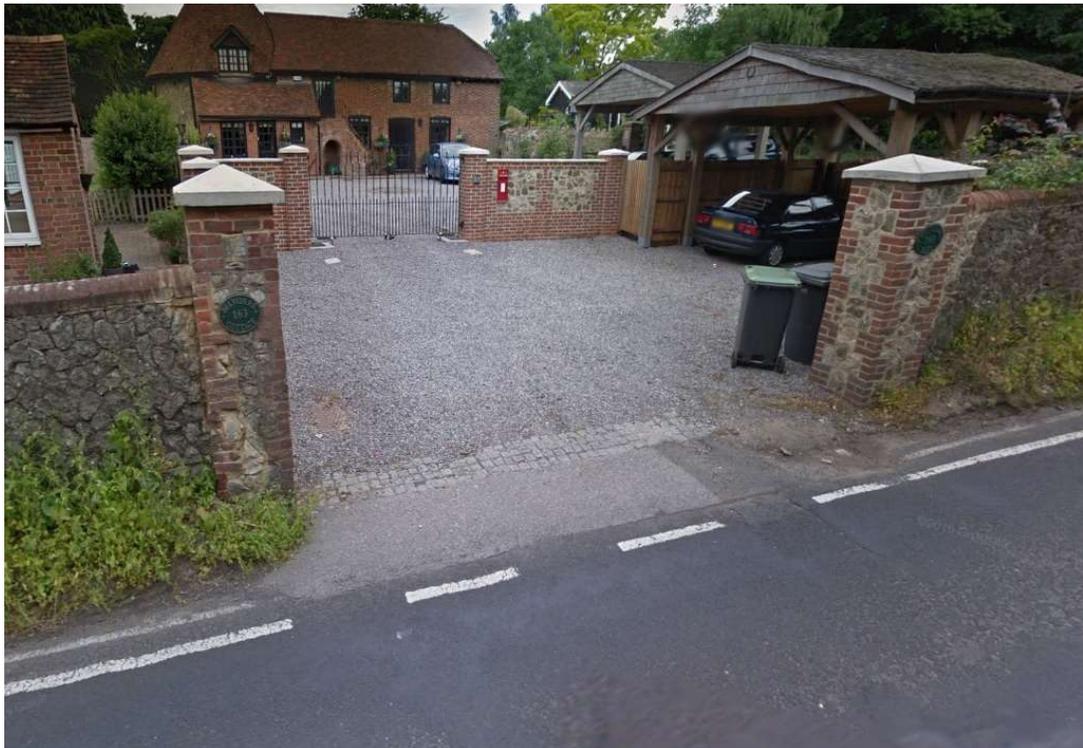
Figure 2.1 – Existing Access

- 2.1.3 The existing access to 165 Wateringbury Road is currently shared along with property 163 and is located on the inside of a sharp bend. The access itself is positioned up close to the edge of the road, with a gap between the property boundary walls approximately 6m in width allowing access to the properties. **Figure 2.1** below shows the existing access.

- 2.1.7 Based on the above and observations undertaken on site is considered that the existing access represents an extremely dangerous situation which has a high risk of causing a serious or worse accident involving existing vehicles and/or vehicles travelling on Wateringbury Road.

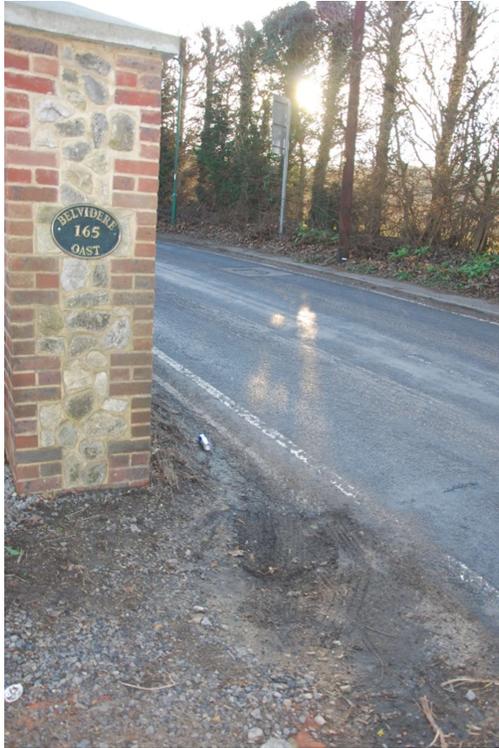
Figure 2.2 - Looking South

- 2.1.4 The visibility from the existing access is extremely limited. **Figure 2.2** and **Figure 2.3** below show the maximum achievable visibility in its current form.

- 2.1.5 With regard to the plans submitted with the planning application (**drawing PL-103B** in **Appendix A**) the existing access is considered to achieve visibility of approximately 25m (Y-distance) of visibility in both directions. It should be noted, however, that this appears to have been measured 1m (X-distance) back from the major road and measured to the offside kerb. Current guidance recommends that visibility be measured from an X-distance of 2.4m to the near side kerb.

- 2.1.6 **Drawing PL-103B** has been updated with an X-distance measurement set back 2.4m, and splays measured 1m offset from the nearside kerb, where vehicles are generally placed on the carriageway. This achieves approximately 5m visibility in both directions which represents a significant safety concern as vehicles traveling on Wateringbury Road have virtually no reaction time to stop and avoid a collision with vehicles exiting the current access. See **drawing 19-038-001** within **Appendix C** for details.

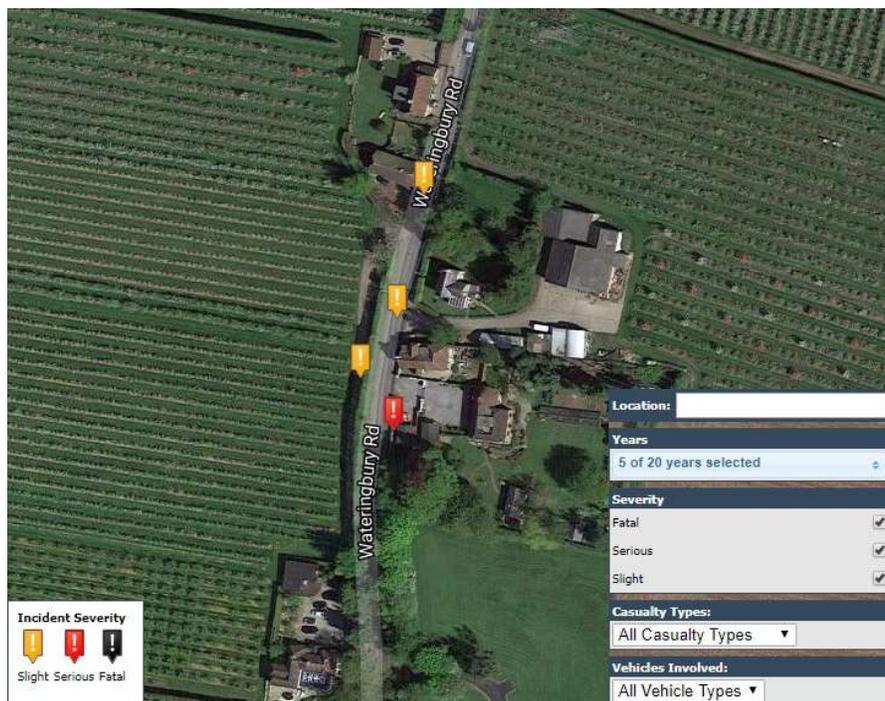
Figure 2.4 – Accident Locations

2.1.8 A review of accidents in close proximity of the existing access has been analysed using data downloaded from www.Crashmap.co.uk. The full accident data reports are contained within **Appendix B** whilst **Figure 2.4** below shows the accident locations which have been categorised by severity as follows:

- Slight;
- Serious; and
- Fatal.

2.1.9 Three slight accidents and one serious accident occurred during a five-year period between 2014-2018 in close proximity to the current access. The serious accident shown in red above, involved a single motorcycle that appears to have lost control on the bend close to the access road.

2.1.10 Although the accident reports do not specifically identify a causation factor directly attributed to the existing access, it is considered that the number of accidents concentrated in this location is significantly higher than normal and unsafe movements manoeuvring out of the existing access could further exacerbate this issue.

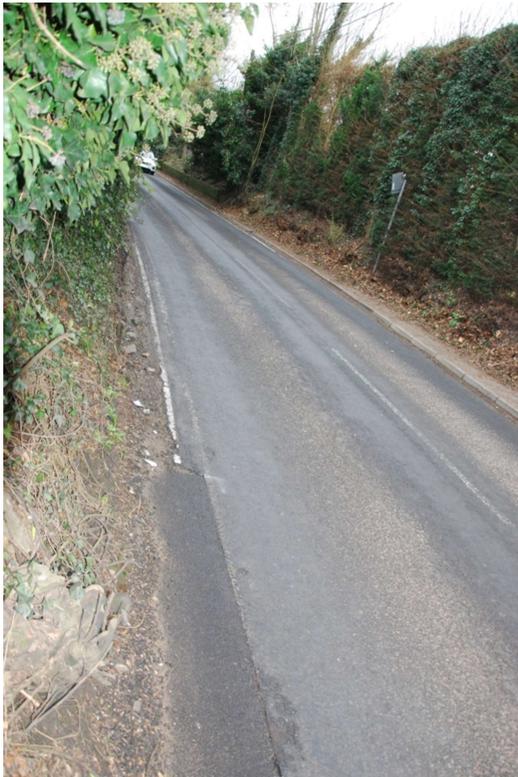
Figure 2.5 - Looking South

- 3.1.1 The proposed access to 165 Wateringbury Road is situated approximately 30m to the south of the existing access, which is to remain as access solely to property no.163.
- 3.1.2 The proposed access location is positioned along a straight section of the Wateringbury Road which naturally leads to improved visibility in comparison to an access on the inside of a bend.
- 3.1.3 During the site visit, photographs were taken to provide a rough indication of the improvement to visibility on the proposed access. **Figure 2.5** and **Figure 2.6** below show the approximate visibility achievable for the proposed access.

- 3.1.4 The access proposal within **drawing PL-103B** shows much improved visibility splays of approximately 45m (Y-distance) in both directions, measured back 3m (X-distance) from the major road.
- 3.1.5 Following current best practice the proposed access visibility has been reviewed adopting an X-distance of 2.4m and measured to the furthest achievable point offset 1 metre from the nearside kerb. The proposed access achieves 37m visibility to the south and 25m visibility to the north as shown in **drawing 19-038-001** contained within **Appendix C** of this report.

- 3.1.6 It is acknowledged that the available visibility from the proposed access falls short of recommended design standards for a 40mph road, however, in comparison to the existing access the proposals represent a significant improvement in safety terms. The achievable visibility to the south is increased by approximately 32m or 640% and to the north by 20m or 400%. The new access and increased visibility affords vehicles travelling on Wateringbury Road significantly more reaction time to avoid collisions in comparison with the existing access.
